# Manhole Inspection Summary

Manhole # S15AA1020MH

**Location** Address: **3645 COTTAGE AVE**

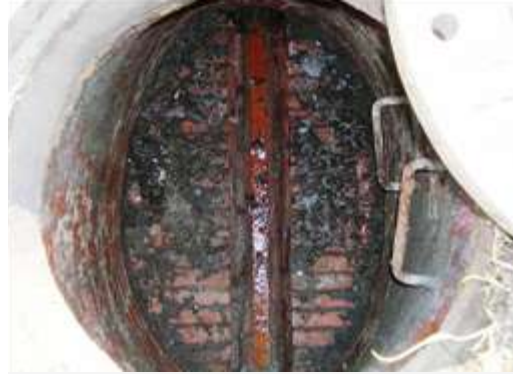
Top View

Corroded steps. Evidence of surcharge - Bench debris.

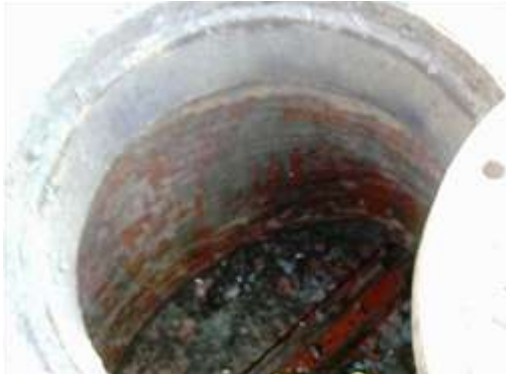
Defect

Frame leaks. Adjustment deterioration and infiltration. Corbel and Barrel infiltration.

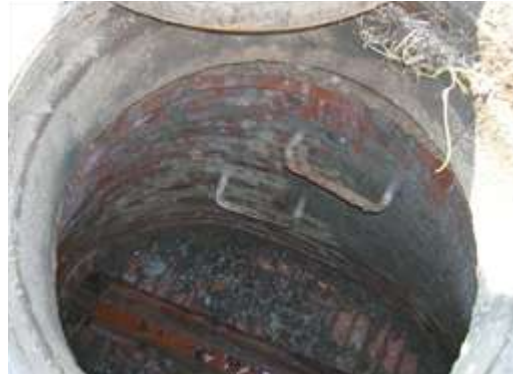
Defect

Frame leaks. Adjustment deterioration and infiltration. Corbel and Barrel infiltration - other side.

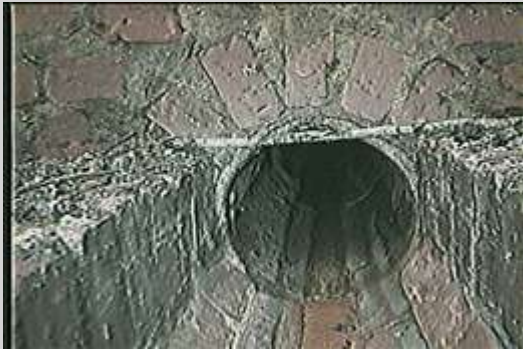
### 8 in. Circular Gravity Sewer Pipe Out @ 12 O'Clock

Deposits: ☐ None ☒ **Mud** ☐ Sludge ☐ Debris ☒ **Grease**

Infiltration: **Evidence** Pipe Seal Cond: **Unknown**

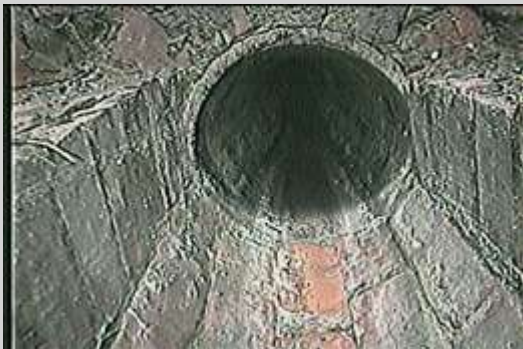
### 8 in. Circular Gravity Sewer Pipe In @ 6 O'Clock

Barrel deterioration and infiltration. Channel deterioration.

Deposits: ☐ None ☒ **Mud** ☐ Sludge ☐ Debris ☒ **Grease**

Infiltration: **Evidence** Pipe Seal Cond: **Cracked**
